Cagle's Copy

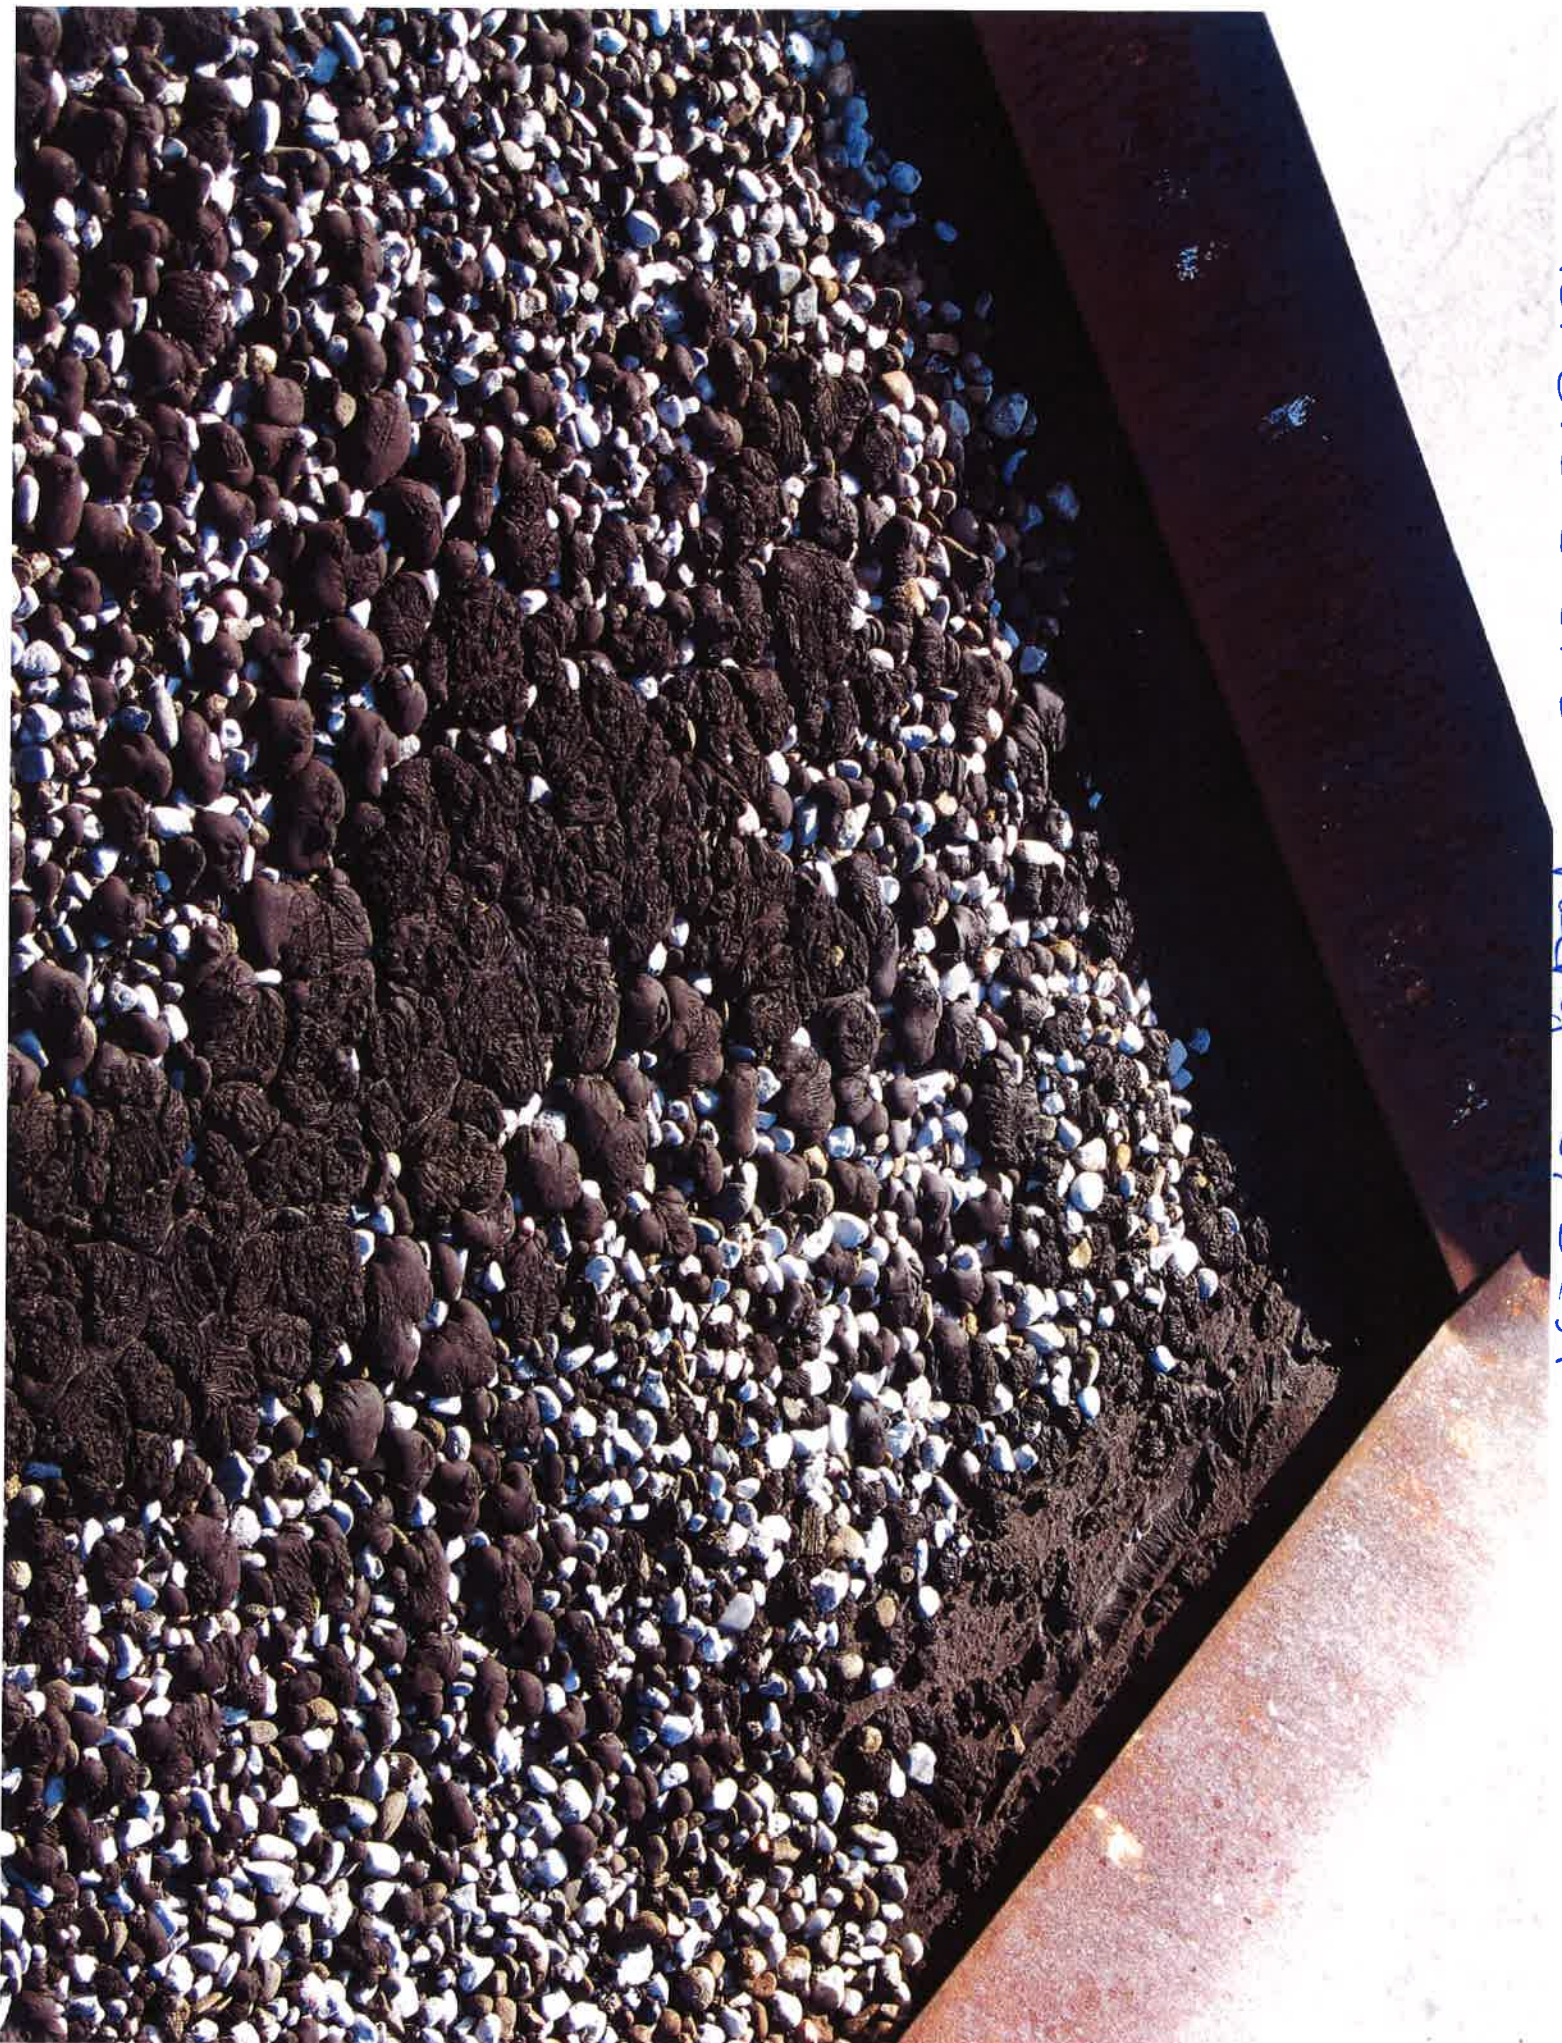
TOP View of Greenhans Sluiceway

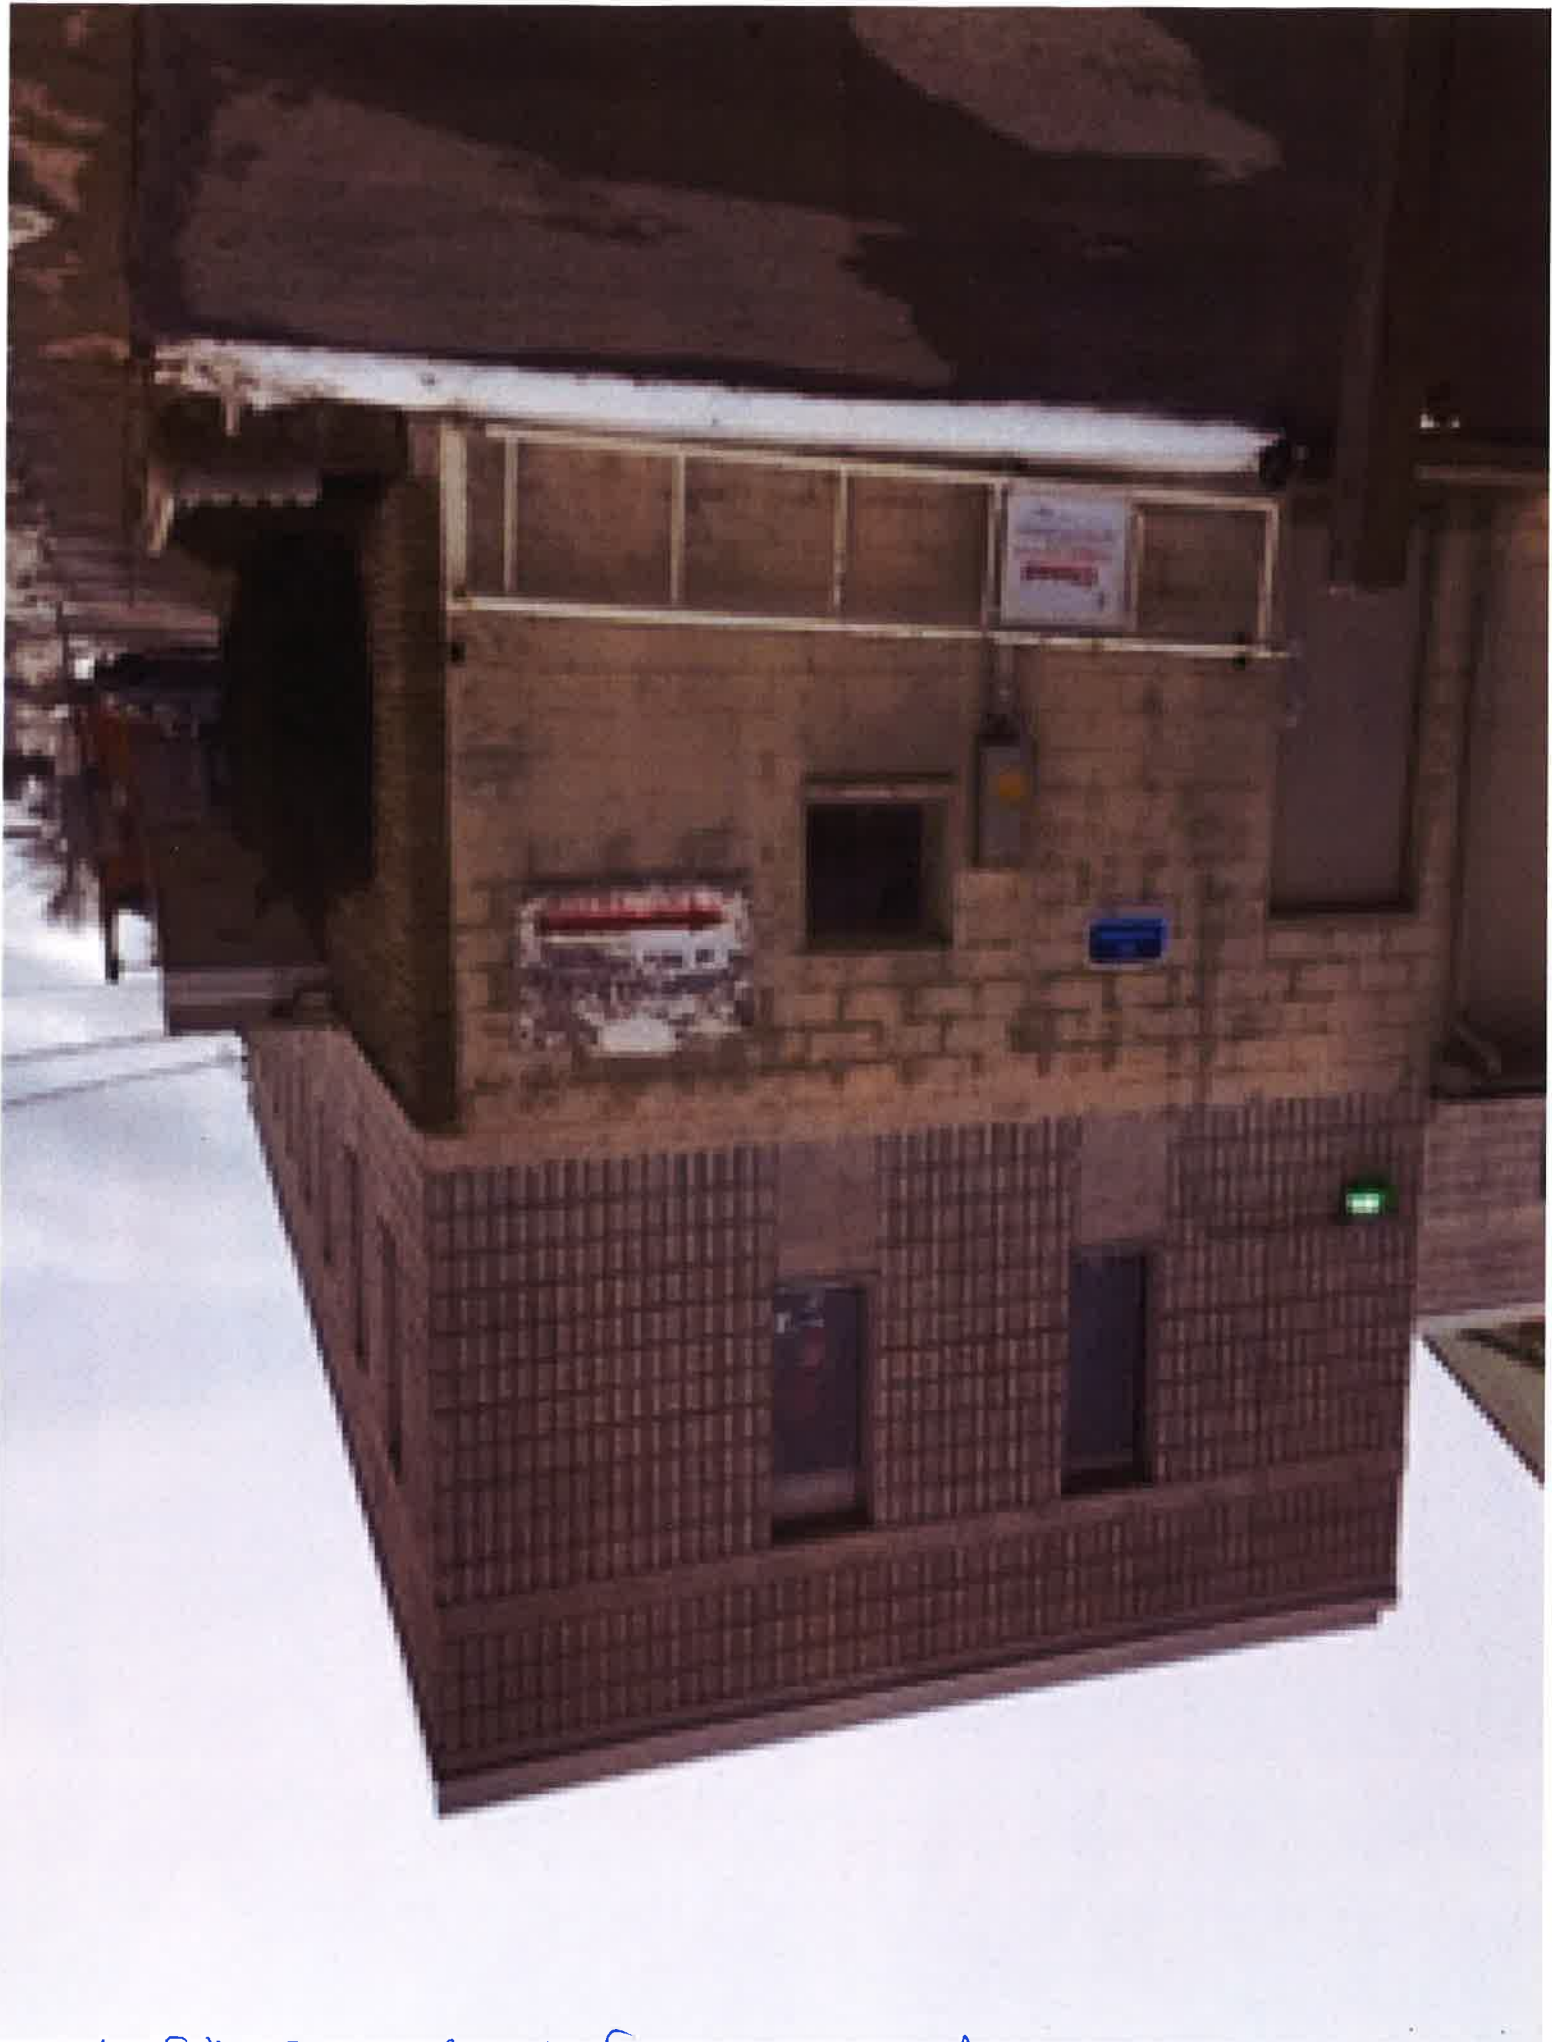
Medicine Penetration of facial walls

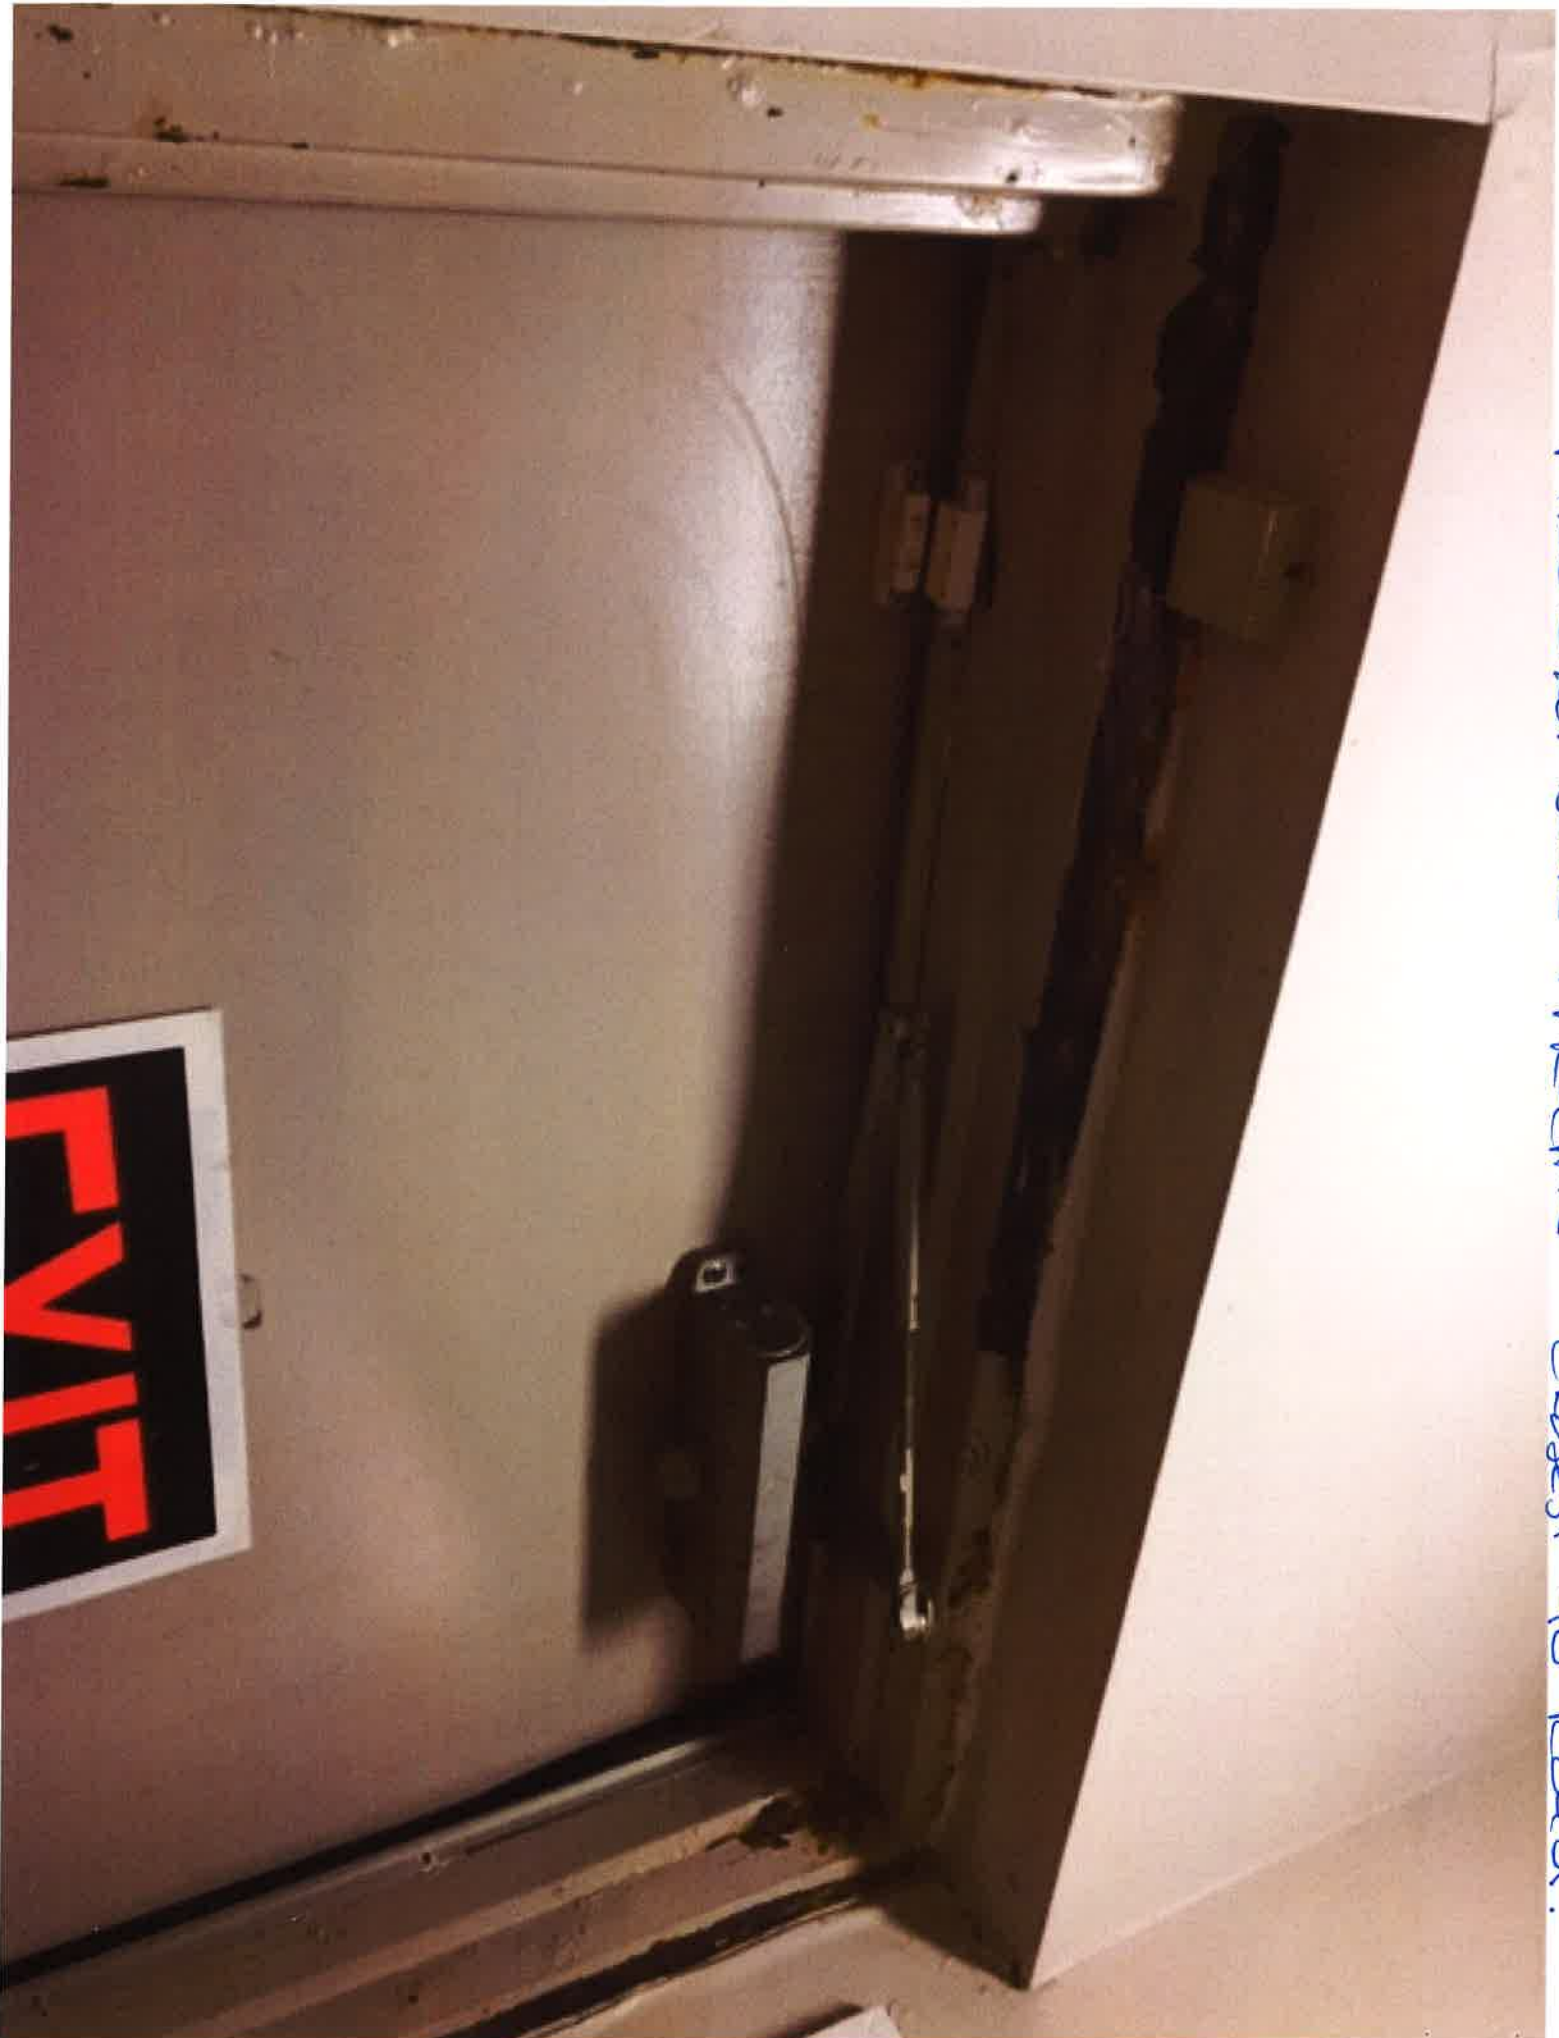
Fire exit door & frame closest to Road.

Under Sink upstairs to Block Wall

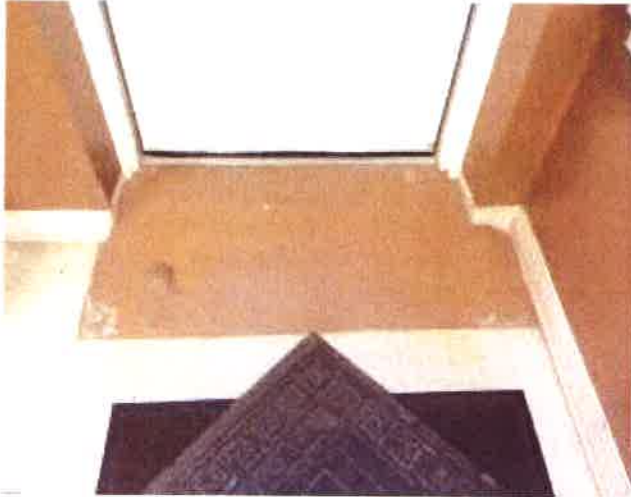
BARRIER- FREE RAMP AT DOOR

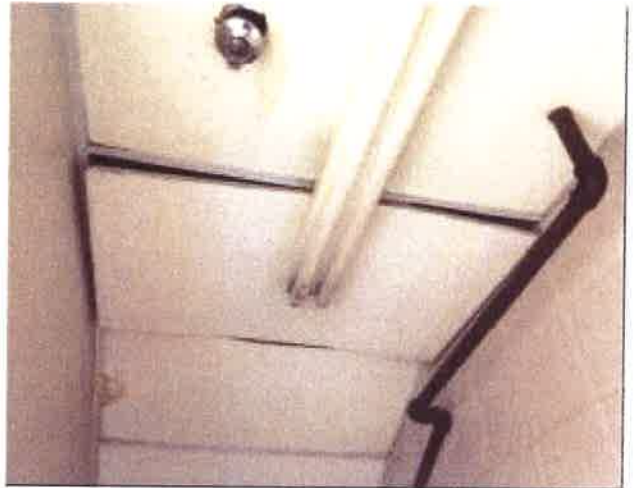
CEILING IN STAIRCASE

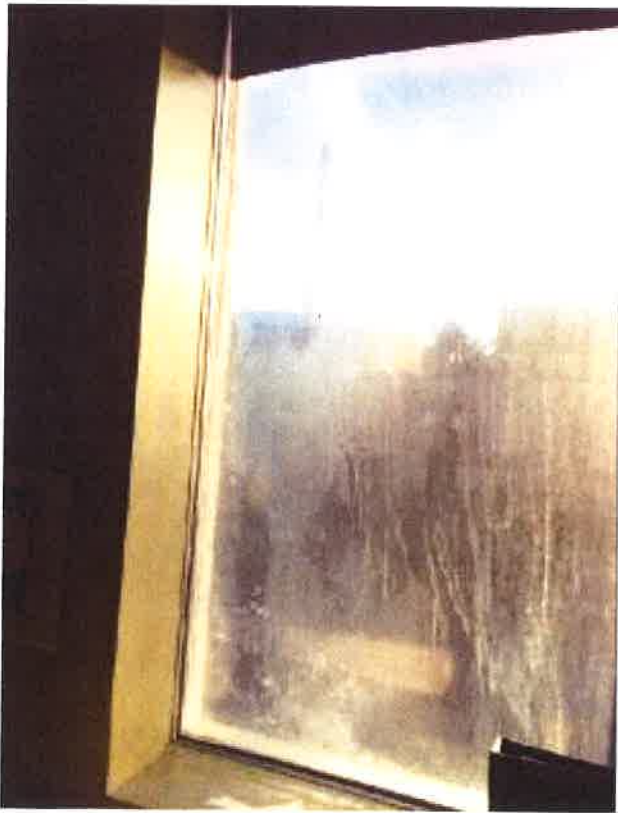
BROCKEN THERMAL SEAL ON WINDOW

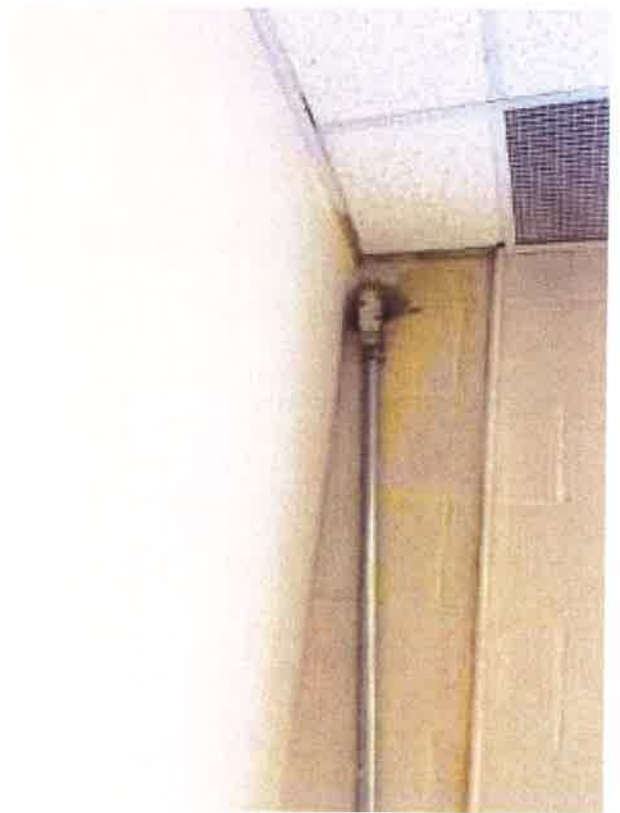
HOLE IN EXTERIOR WALL

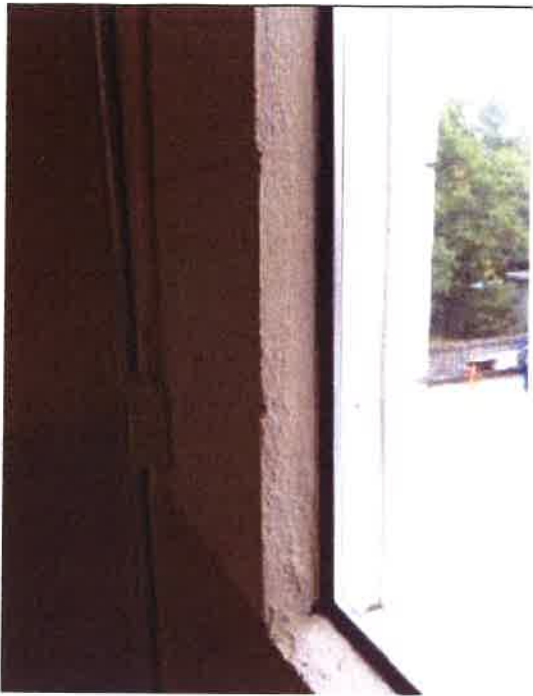
*Board Room .*

NO THERMAL INSULATION IN EXT. WALLS

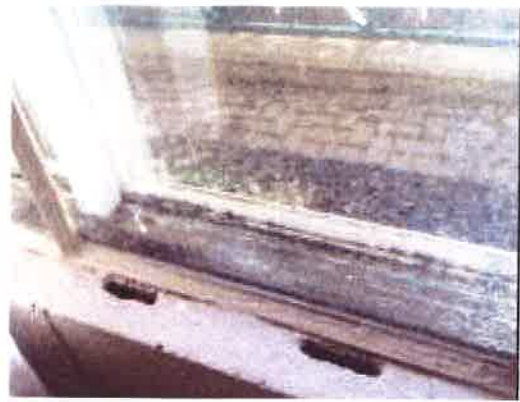
POSSIBLE MOULD ON WINDOW FRAMES

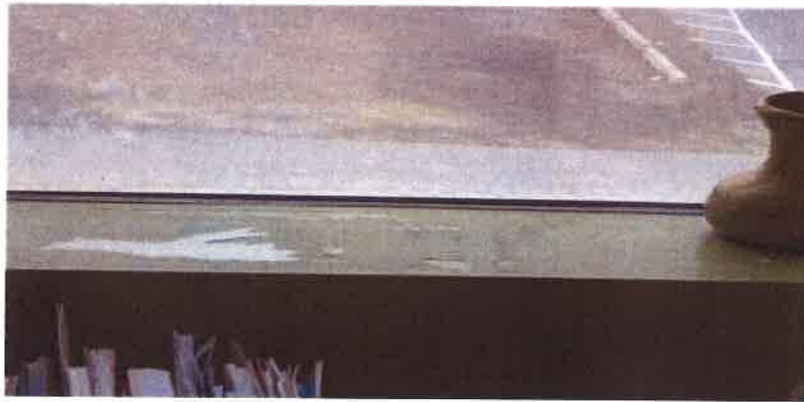
RESULTS OF CONDENSATION ON WINDOWS

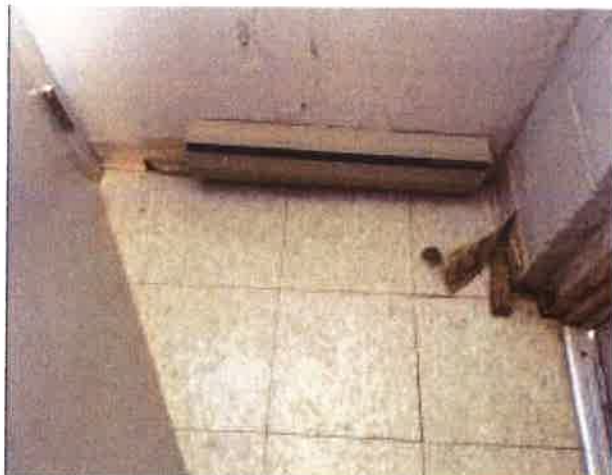
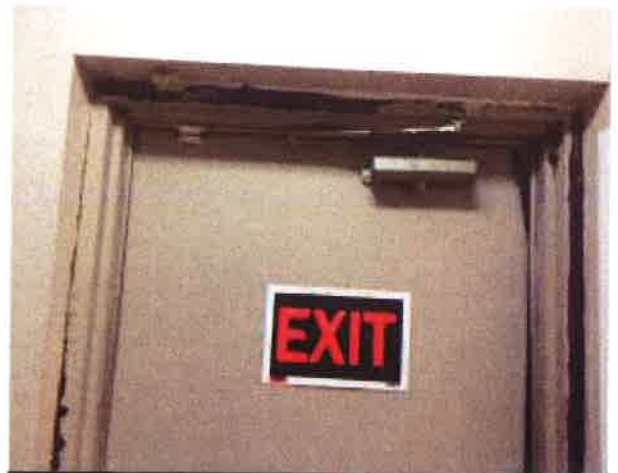
EXTERIOR DOOR FRAME AND WALL CONDITION

Moisture | Condensation | Rust.

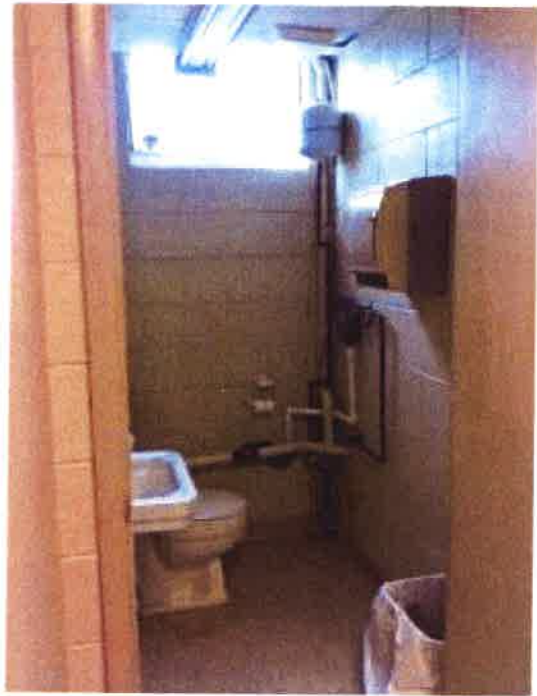
*- people  
have hit their  
heads.*

PIPING TO BE ENCLOSED  
INTO WALL SPACE

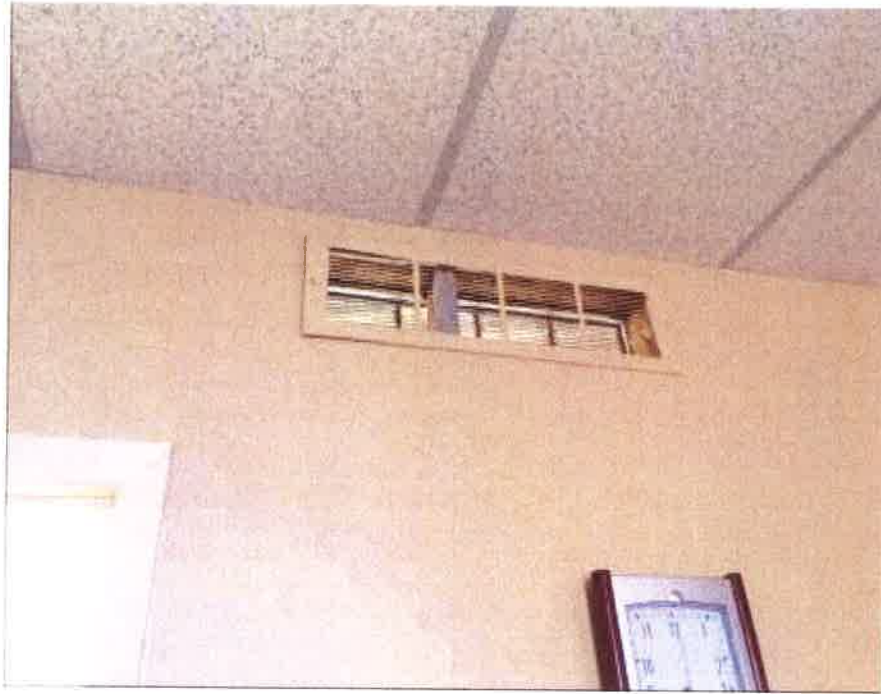
SOUND TRANSFER BETWEEN THE CORRIDOR AND THE OFFICE

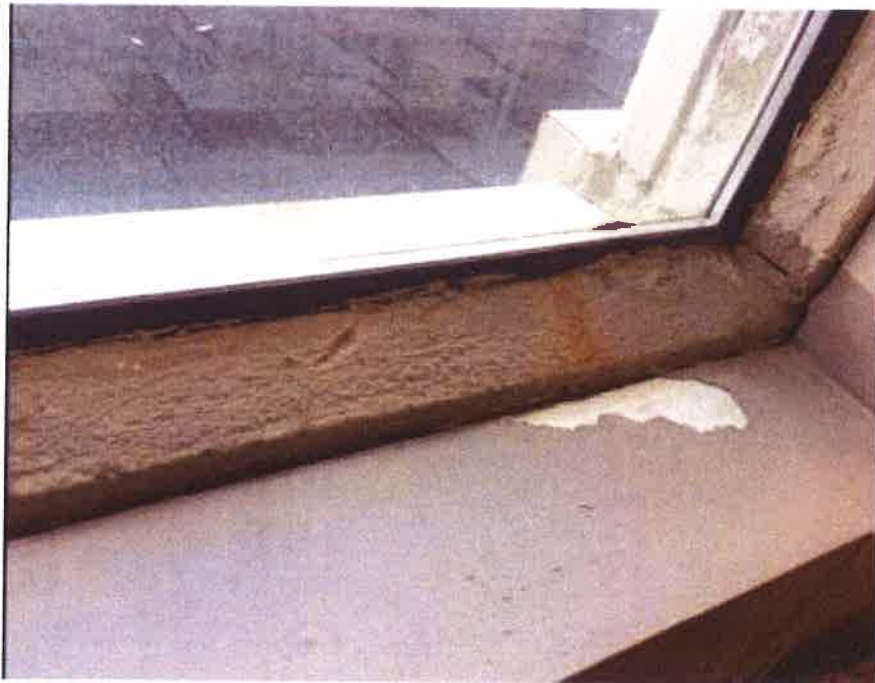
'THERMAL BRIDGE' BETWEEN INTERIOR AND EXTSRIOR  
MAKES INSULATION INEFFECTIVE

Cold  
Damp -  
Difficult  
to Regulate  
Temperature.

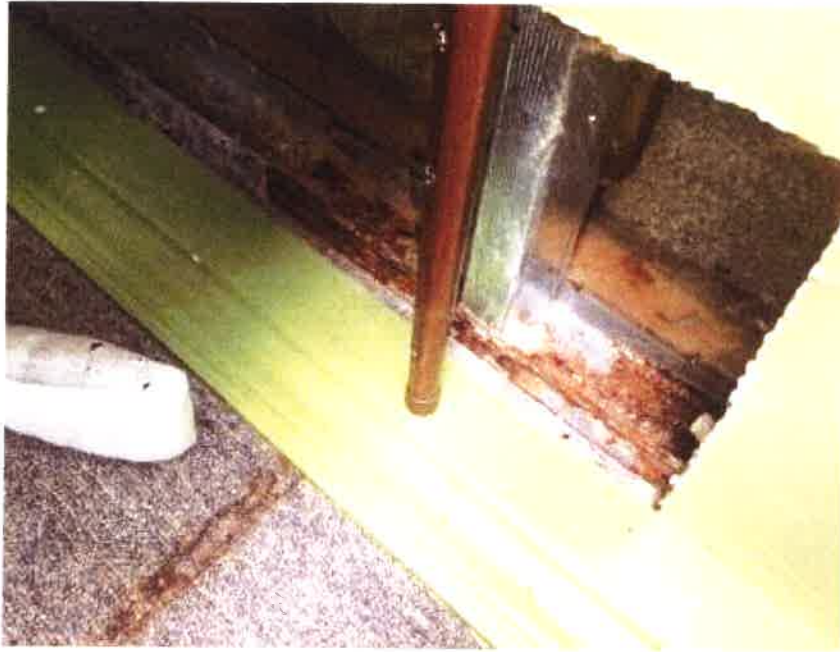
Seepage  
FROM  
Overhang  
into E'D'S  
Office Desk  
area.

WATER DAMAGE IN WALL

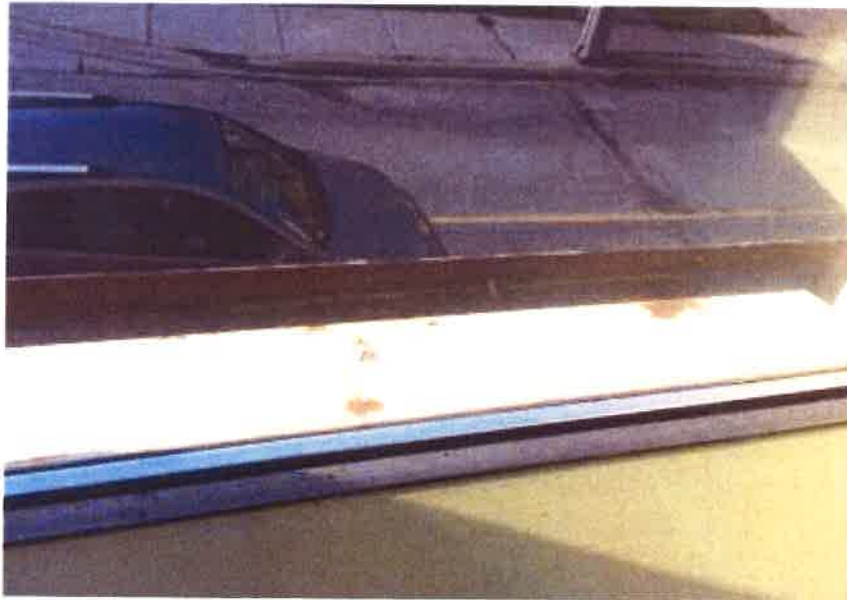
RUSTED OUT WINDOW FLASHINGS
